LIBRARY
United States Department of Agriculture
Agricultural Research Administration
Bureau of Entomology and Plant Quarantine

INSTALLATION OF WINDOWS IN PANELS OF A SEDAN DELIVERY TRUCK

By O. E. Berndt
Division of Cereal and Forage Insect Investigations

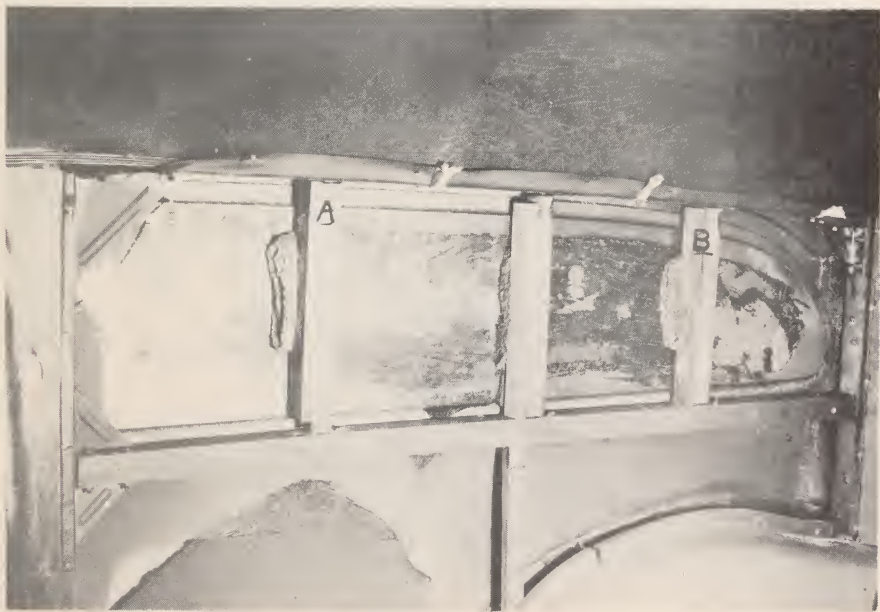
The inside fiberboard wall covering the framework of the car is first removed to expose the bracing members as installed at the factory. The two struts A and B in figure 1, lateral of the center strut, are then removed.

Figure 1.--Interior view of truck showing fiberboard removed, exposing side wall bracing. Struts A and B are removed to permit window installation.

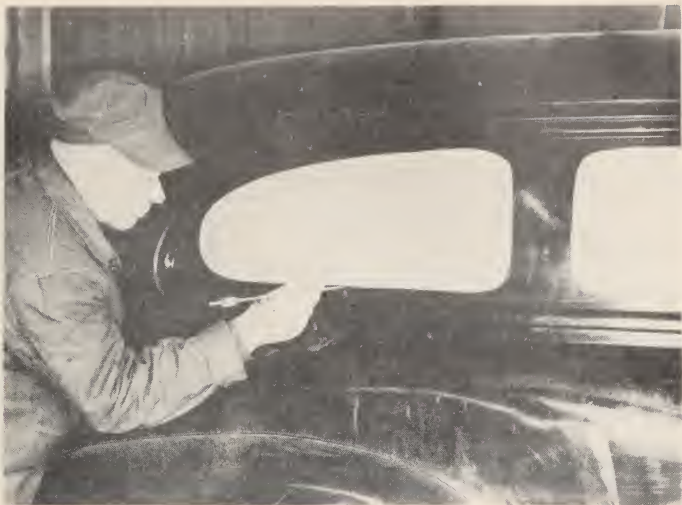
A paper template is made and pasted on the outside surface of the panel in the position in which the windows are to be cut. The template follows as nearly as practical the contours of the panel. A 1-inch margin was left between the edge of the template and the edge of the panel in the truck illustrated. If the panels are larger, a wider margin is allowed in the interest of proper proportioning, appearance and strength. With the template in place, a scribe is used to mark the line of the cut on the metal surface (fig. 2).

Figure 2.—Exterior view of truck, showing paper template attached to panel surface. Scribe is drawn around edge of template to mark cutting line.

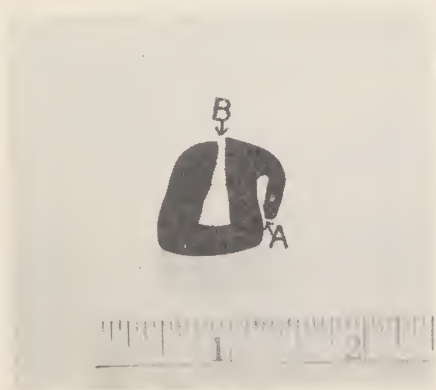
A strip of channel rubber similar to that commonly used in installing automobile windows is worked over the cut edge of the metal with a screw driver or a similar tool, so that the narrow groove in the rubber fits over the metal edge (fig. 3-A). The rubber strip is cut so that a tight butt joint is made at the top of the window. This joint is later sealed with liquid rubber and sanded until it is practically invisible.

The rubber is then removed and fitted over a glass pane cut to a size $\frac{1}{4}$ inch larger all around than the opening into which it is to be fitted. The pane with its periphery imbedded in the wide groove (fig. 3-B) of the channel rubber is then inserted in the opening with the overlap of the pane on the inside of the panel.

Figure 3.—Cross section of channel rubber, showing grooves in which glass and metal are imbedded.

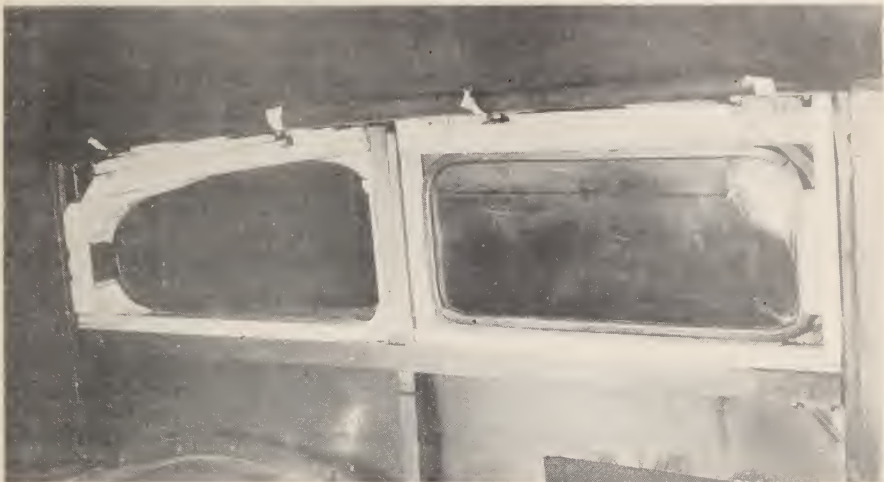
When the pane is in place, the framework of the window is formed with wood pieces fashioned to conform to the contours of the window, and attached solidly with nails and screws to the remaining original supporting framework (fig. 4). The curved corners can be installed most easily by use of short metal strips. A strip of a neutral shade of standard-gage linoleum is fastened to the new framework with small box nails and cut to a width equal to the thickness of the frame (fig. 5). The inside fiberboard wall is then attached in its original position, and the window openings are cut to correspond exactly with the edges of the linoleum strip on the window framework.

Figure 4.--New casing around rubber on inside of panel to replace bracing and provide solid backing for tacking fiberboard wall and trimming at window sill.

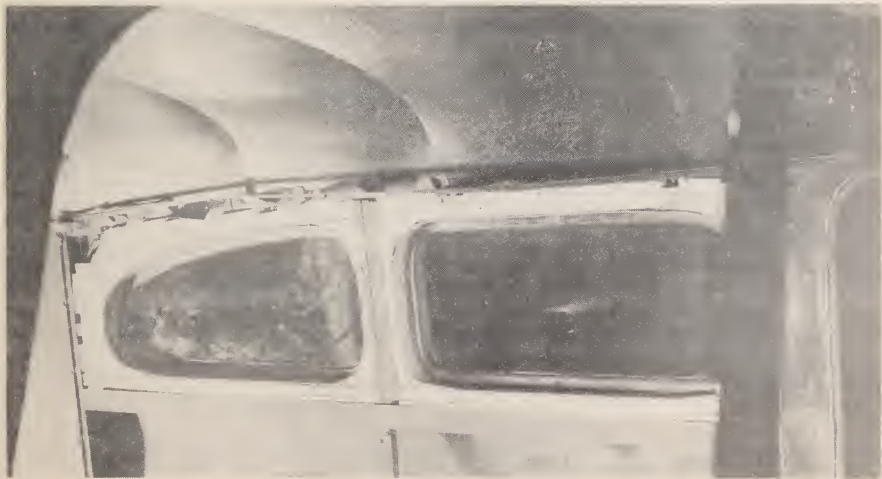
Figure 5.--Completed interior installation, showing casing and linoleum strip in place prior to replacing fiberboard wall.

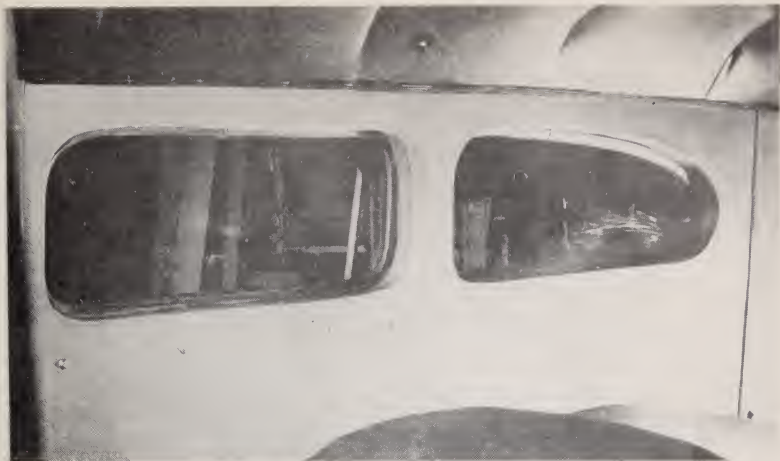
Figure 6.--Interior view showing completed job with fiberboard wall in place and window opening trimmed to sill.

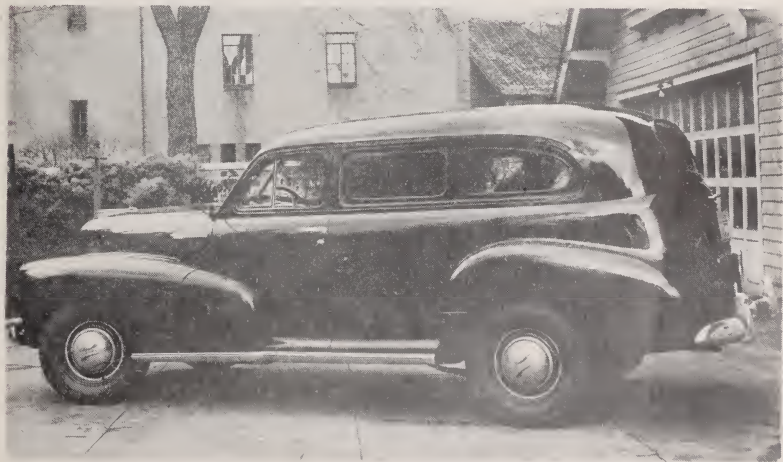
Figure 7.--Exterior view of truck with window installation completed.
